From: <Pete_Sokolosky@ut.blm.gov>
To: <nrogm.tgallego@state.ut.us>
Date: 11/14/00 1:56PM
Subject: October 23, 2000 inspections and Notices of Noncompliance

3809 REPORT OF INSPECTION

Serial no. of notice: UTU 66357 (Bluebell Oil Co project area) Is the operation active?
No

Serial no. of notice: UTU 66358 (Hiko Bell project area) Is the operation active? No

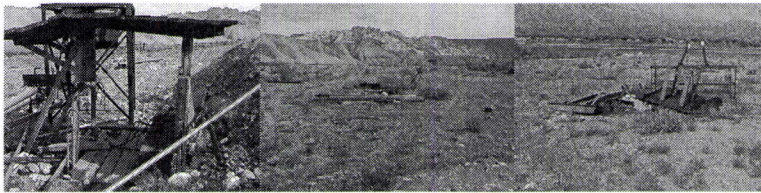
image 1 western part of project area,
pole south of project
inactive grizzly screen, separation
bowl and open wooden structure

image 2 western part of project area, compare
with image 5 of July 20, 2000 inspection

image 3 power drop at
area, compare with image 6 of July 20, 2000
inspection.

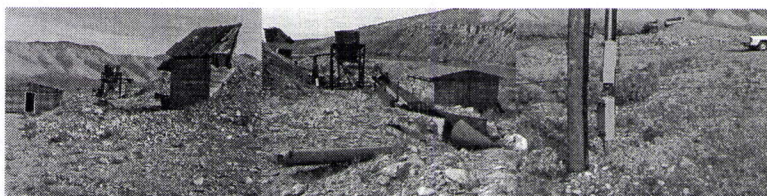
image 4 area once housed electric
southeastern part of
panel - compare with image 7 of
15 of July 23,
July 23, 2000 inspection

image 5 miscl. equipment in northwestern part
of project area - compare with image 14 of July
23, 2000 inspection

image 6 miscl. supplies in
project area - compare with image
2000 inspection

image 7 piece of processing equipment
left just east of loading hopper (in distance
in image 17 of July 23, 2000 inspection).

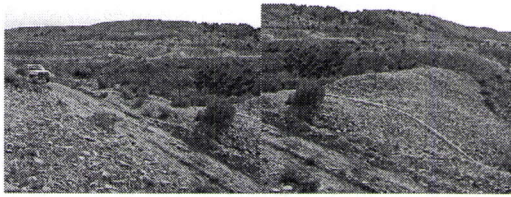
image 1 view to east-southeast of east-west access road, sediment area dam and settling area [dried, right-center], excavation high wall [above truck]- compare with image 6 of July 20, 2000 inspection

image 2 view to right of image 1 (sediment settling southwestern part of project area - compare with image 7 of 20, 200 inspection

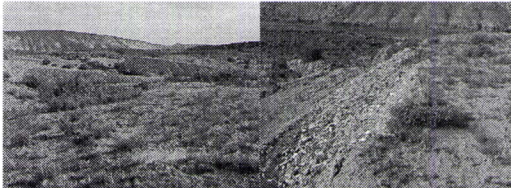
image 3 view to west of constructed access road to Green drainage - River (note cut at lower left to center of image) - compare with image 8 of July 20, 2000 inspection

image 4 view to east-northeast of cobble pushed into compare with image 10 of July 20, 2000 inspection

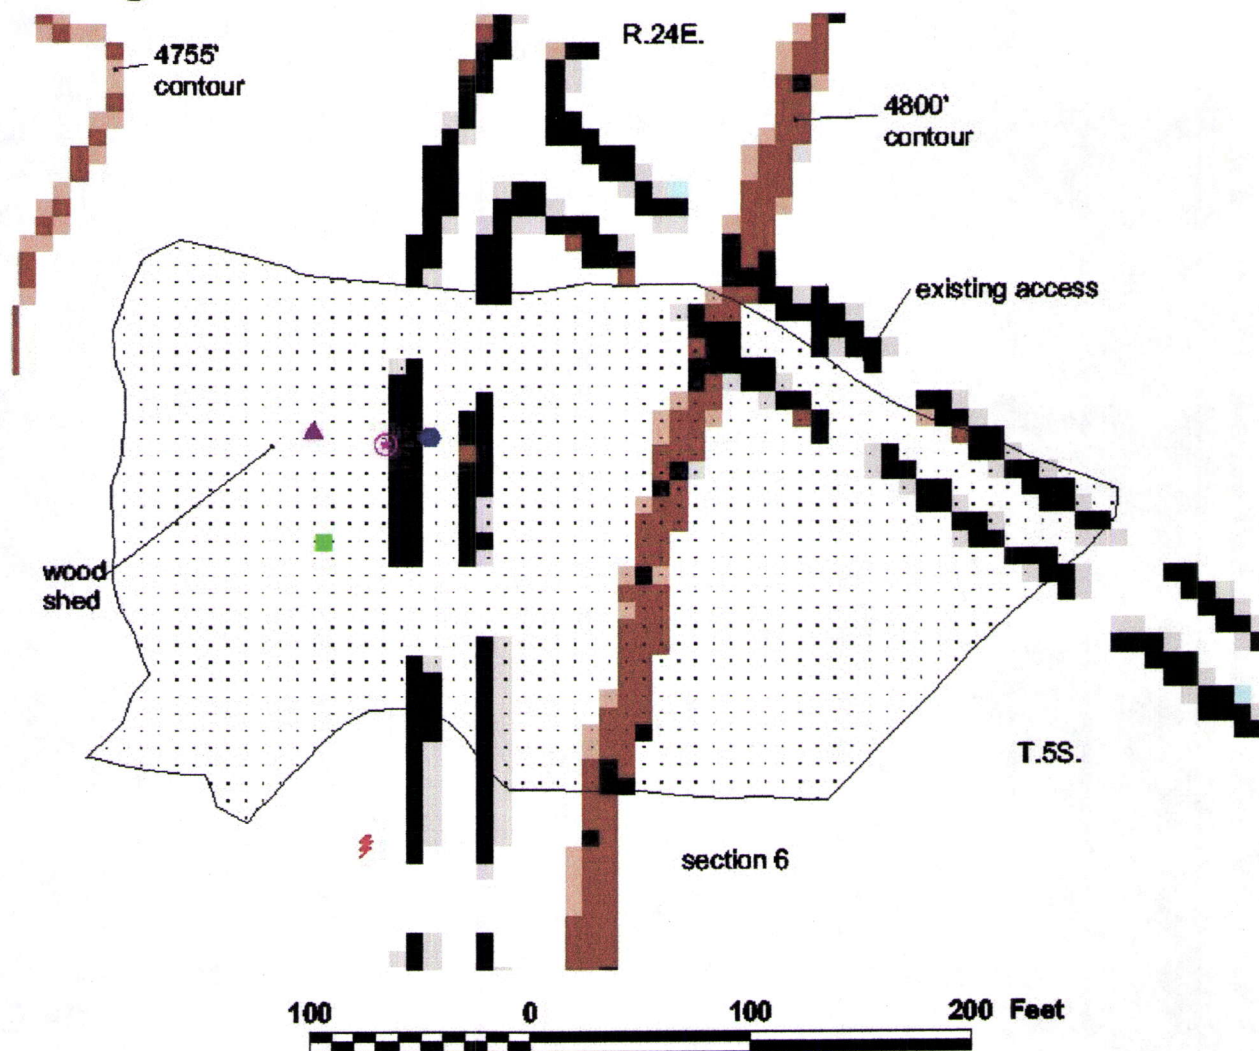
figure 2 UTU66357 Oct. 23, 2000 inspection

scale 1:850; project areas based upon October 23, 2000 GPS measurements

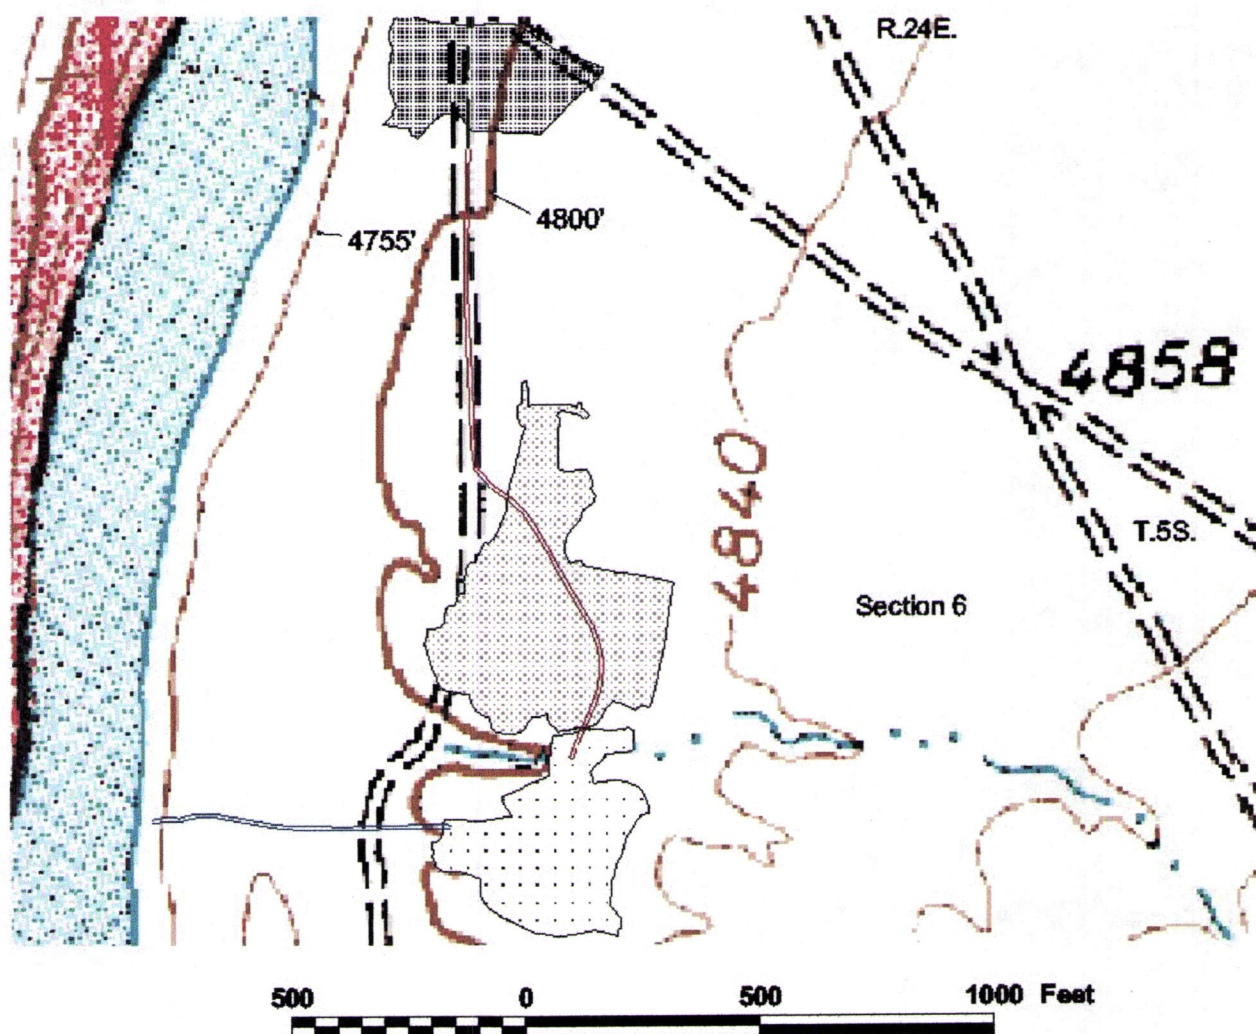
figure 1 UTU66358 Oct. 23, 2000 inspection

scale 1:4,000; project areas based upon October 23, 2000 GPS measurements

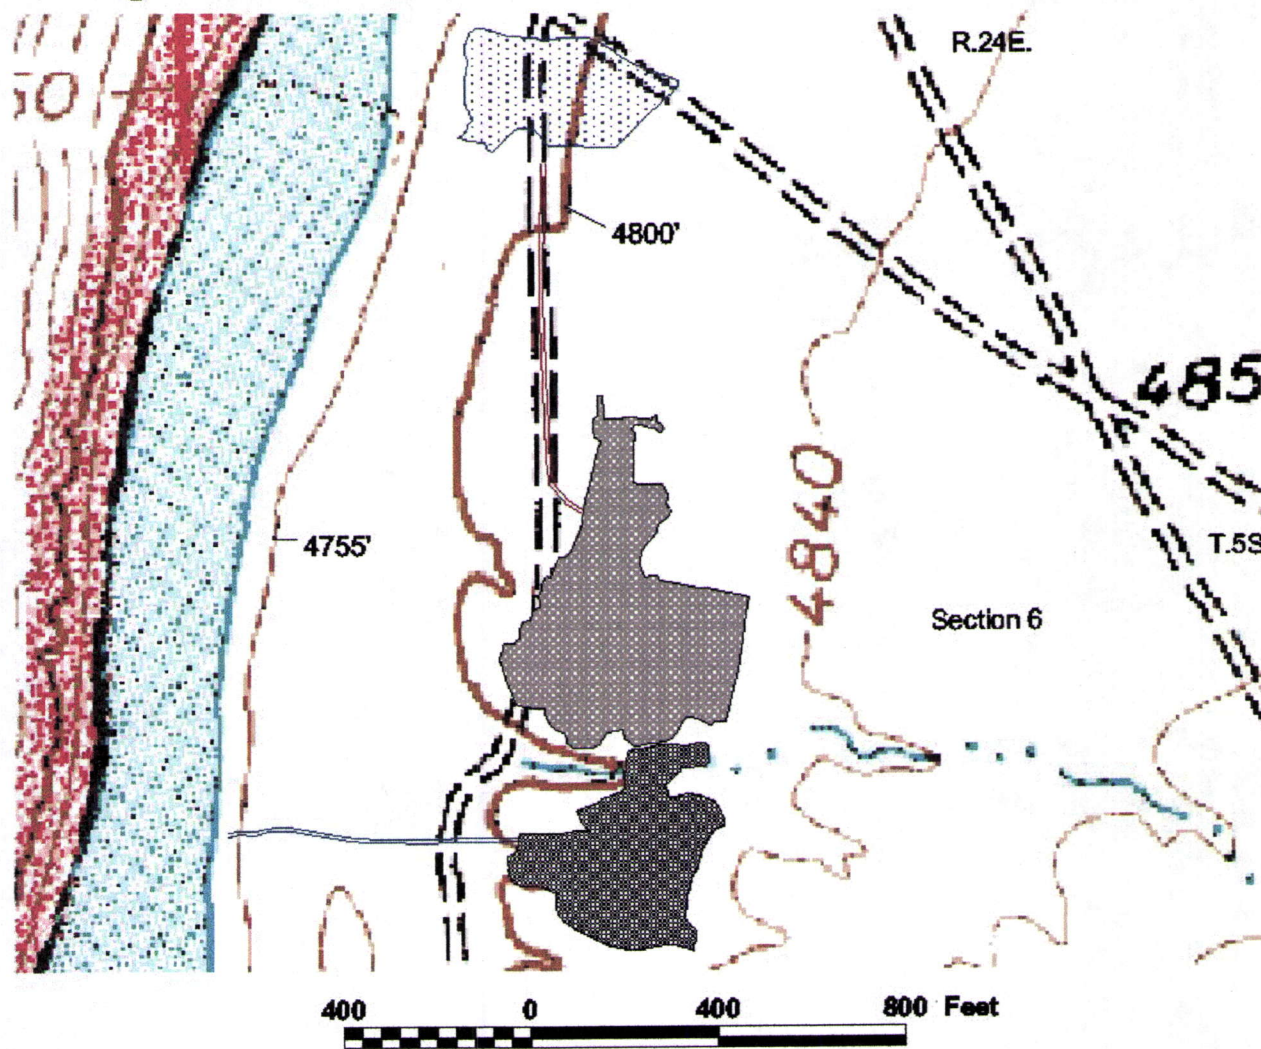
figure 1 UTU66357 Oct. 23, 2000 inspection

scale 1:4,000; project areas based upon October 23, 2000 GPS measurements
